Technical Report CHL-99-7
April 1999

Dam Safety Assurance Model Study of Tygart Dam, Tygart River, Grafton, West Virginia

Final report

Prepared for U.S. Army Engineer District, Pittsburgh
Pittsburgh, PA 15222-4186

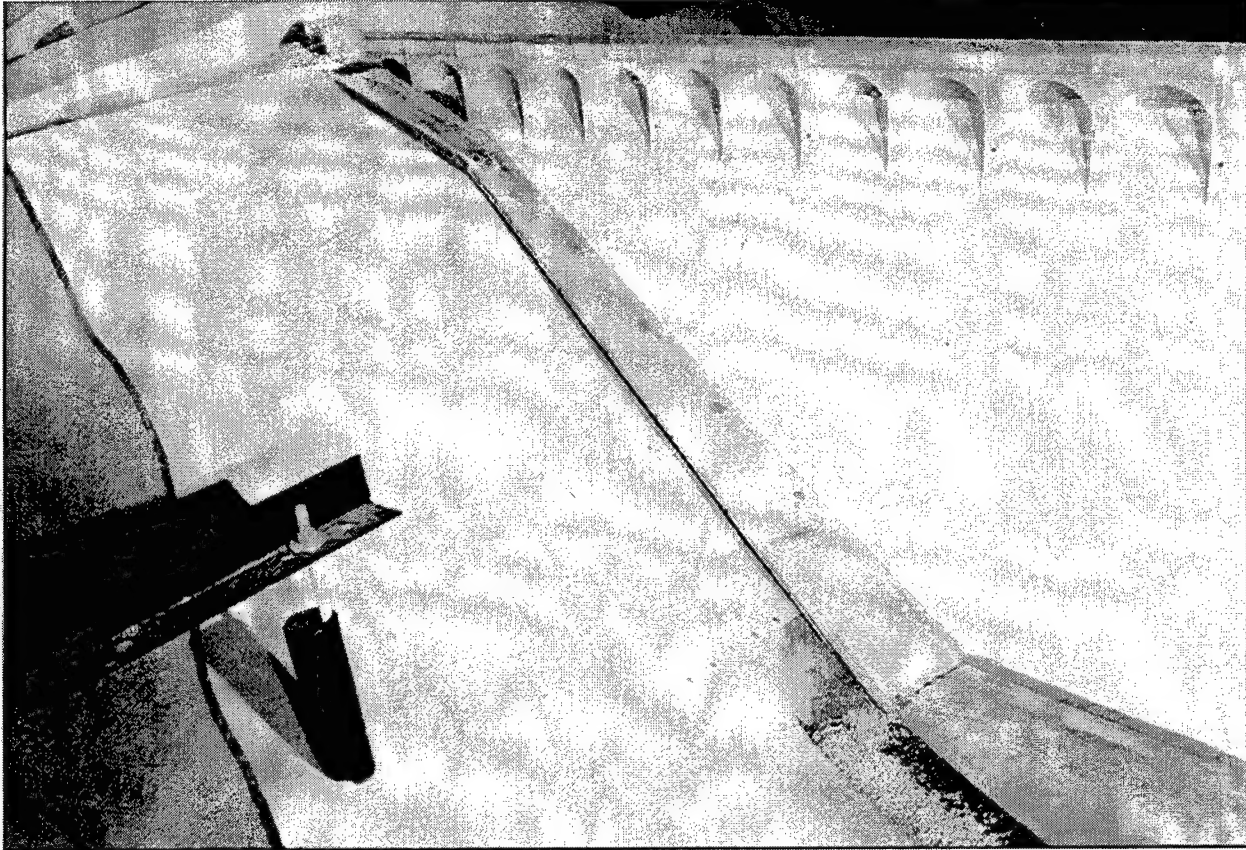
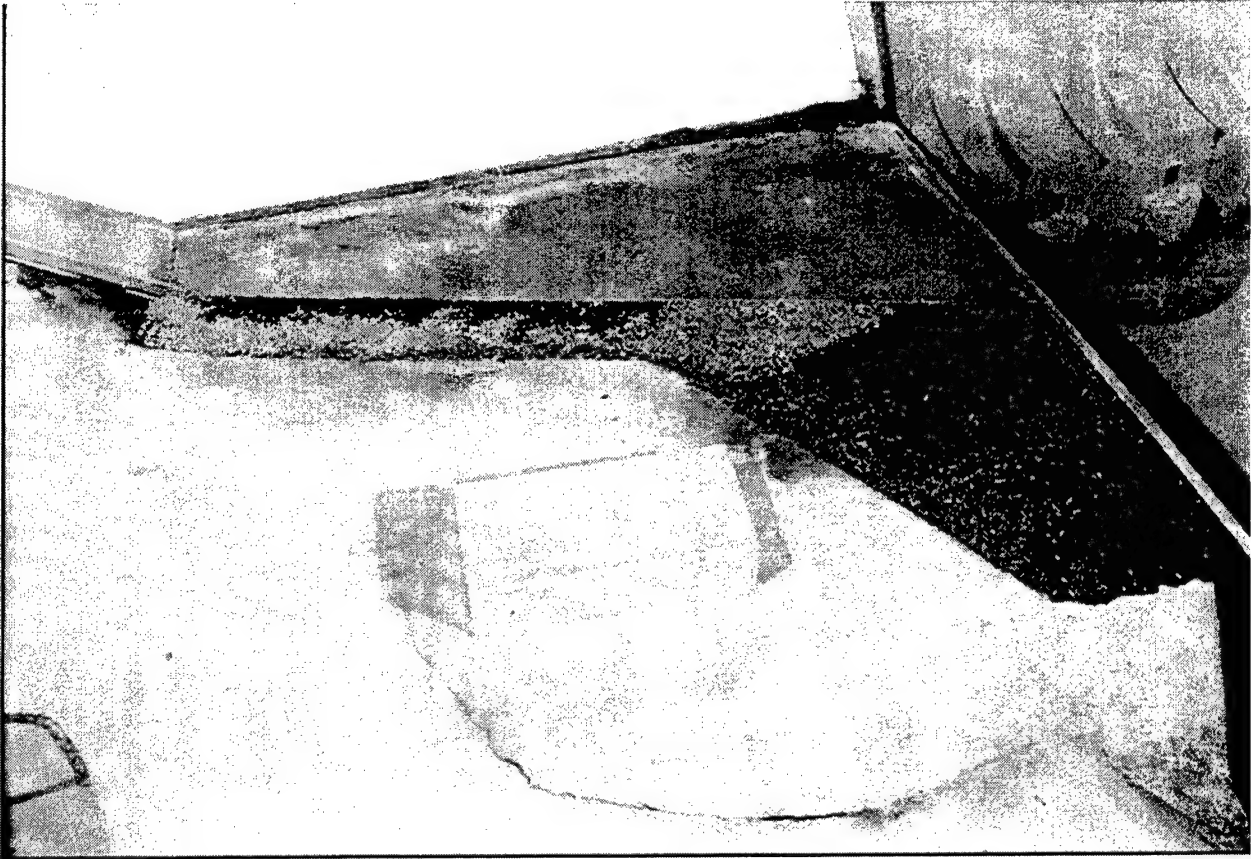
Photo 13. Type 2 design, gutter channel, dry bed, right side of dam

Photo 14. Type 2 design, apron and riprap, dry bed, right side of dam

The Type 2 design gutter channel is shown in Photos 13-14. Details of the Type 2 design are shown in Plate 10. At the top of the slope, the gutter is 6.1 m (20 ft) wide to allow for the roadway flow and to compensate for arch interference with the flow. At the toe of the slope, a paved apron was designed to allow the gutter flow to expand on the flat area. Riprap borders the apron and stilling basin to reduce erosion. Observations of the flow conditions with Condition D indicated that a barrier along the road was needed to prevent any flow from entering by the road.

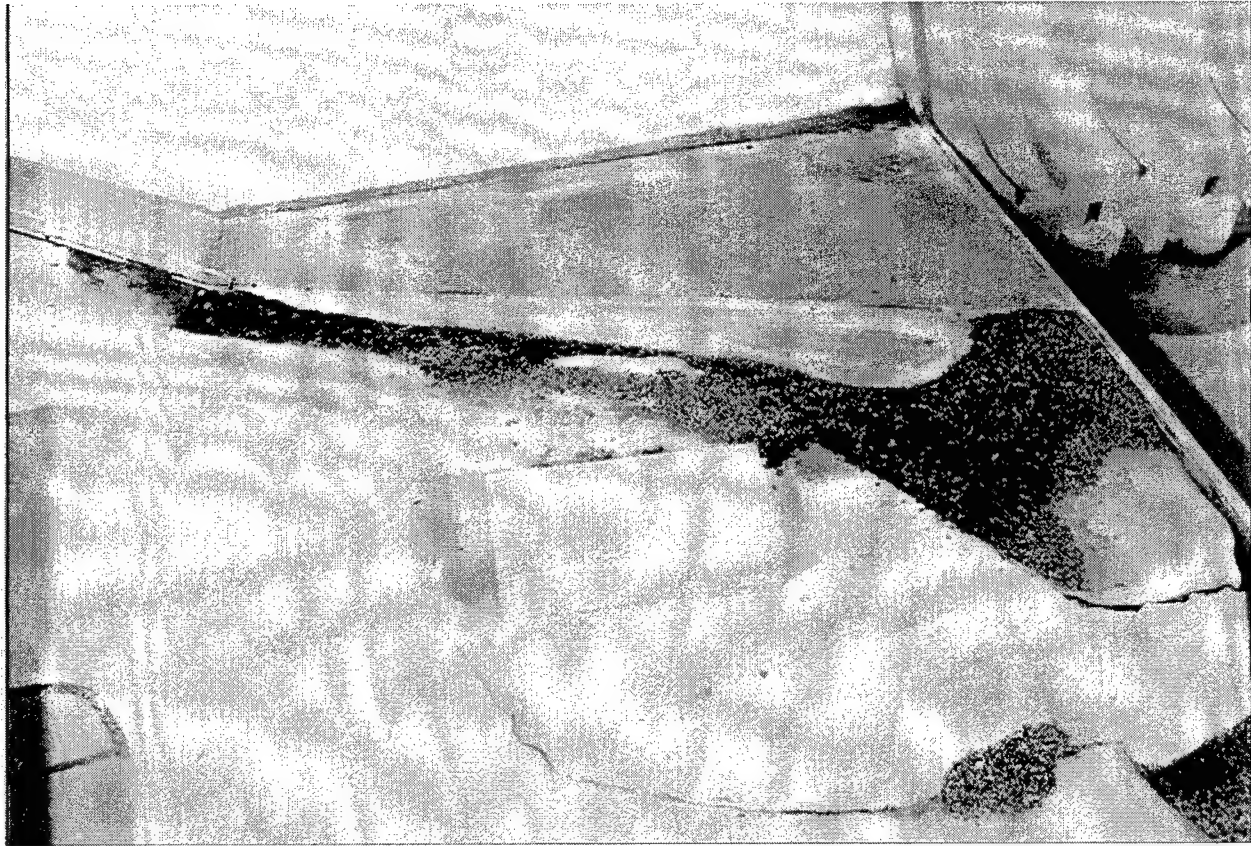
Photo 15. Type 2 design, damage resulting from PMF flow for 1 hr (proto), right side of dam

For performance and evaluation purposes, the modification was subjected to the PMF for a duration of 1 hr prototype (7.75 min model). Results of the Type 2 design, Photo 15, show that the flow upon leaving the confined gutter section expanded more than estimated and eroded the riprap protection. Failure of the downstream section of the riprap was caused by wave action from the stilling basin.

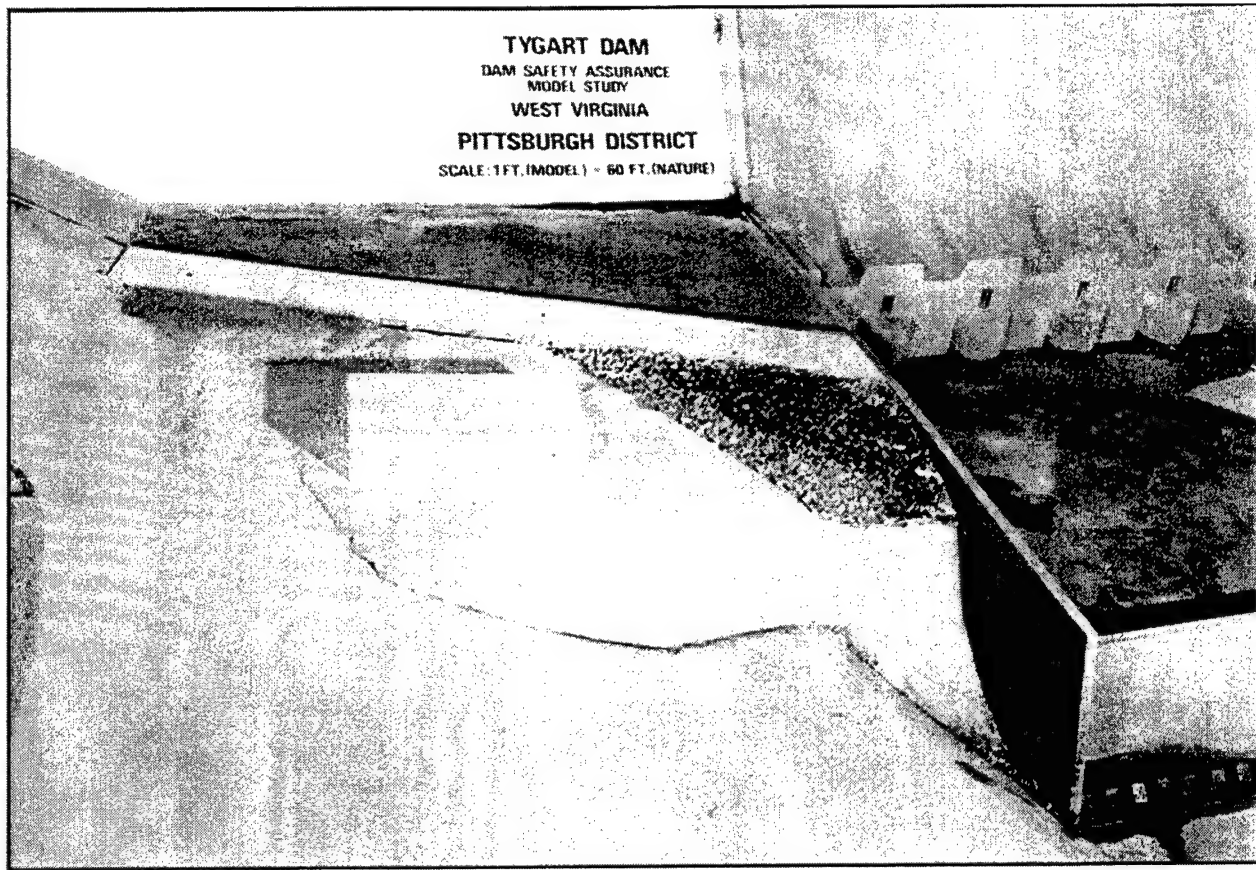
Photo 16. Type 3 design, apron and riprap, dry bed, right side of dam

Because of failure of the riprap with the Type 2 design, the Type 3 design, Photo 16, was developed. This design expanded the concrete apron 30 ft and used larger riprap. Dimensions of the Type 3 design are shown in Plate 11. After subjecting the design to the PMF for 1 hr prototype (7.75 min model), damage because of flow expanding from the gutter and stilling basin wave action was still present, as shown in Photo 17.

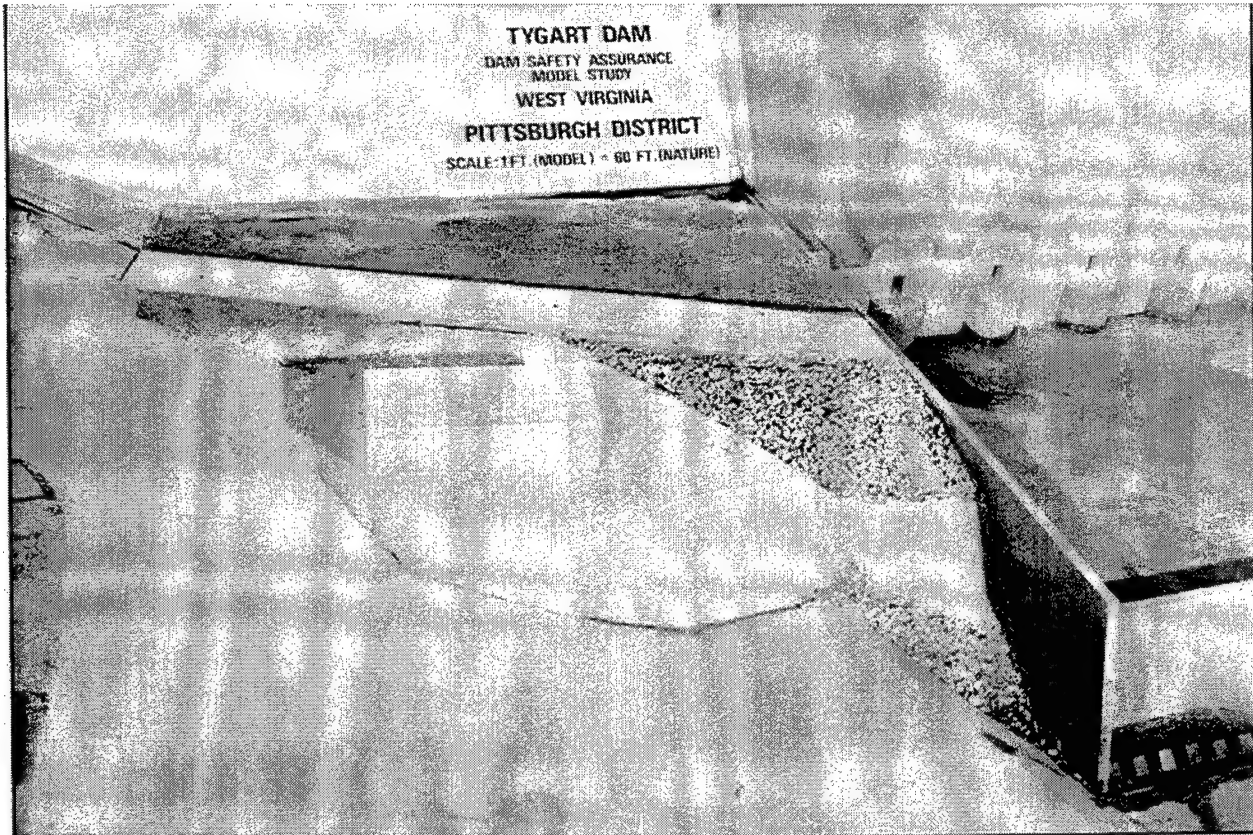
Photo 17. Type 3 design, damage resulting from PMF flow for 1 hr (proto), right side of dam

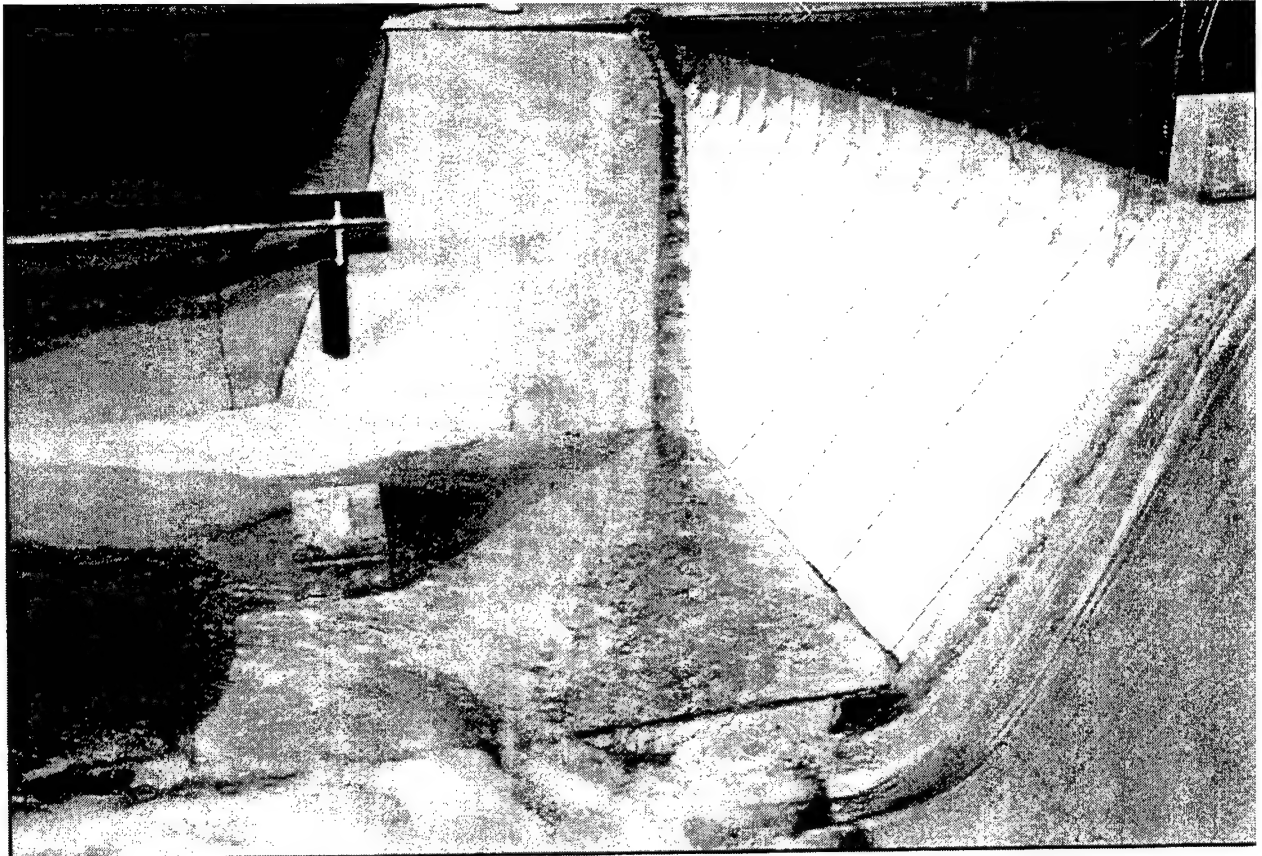
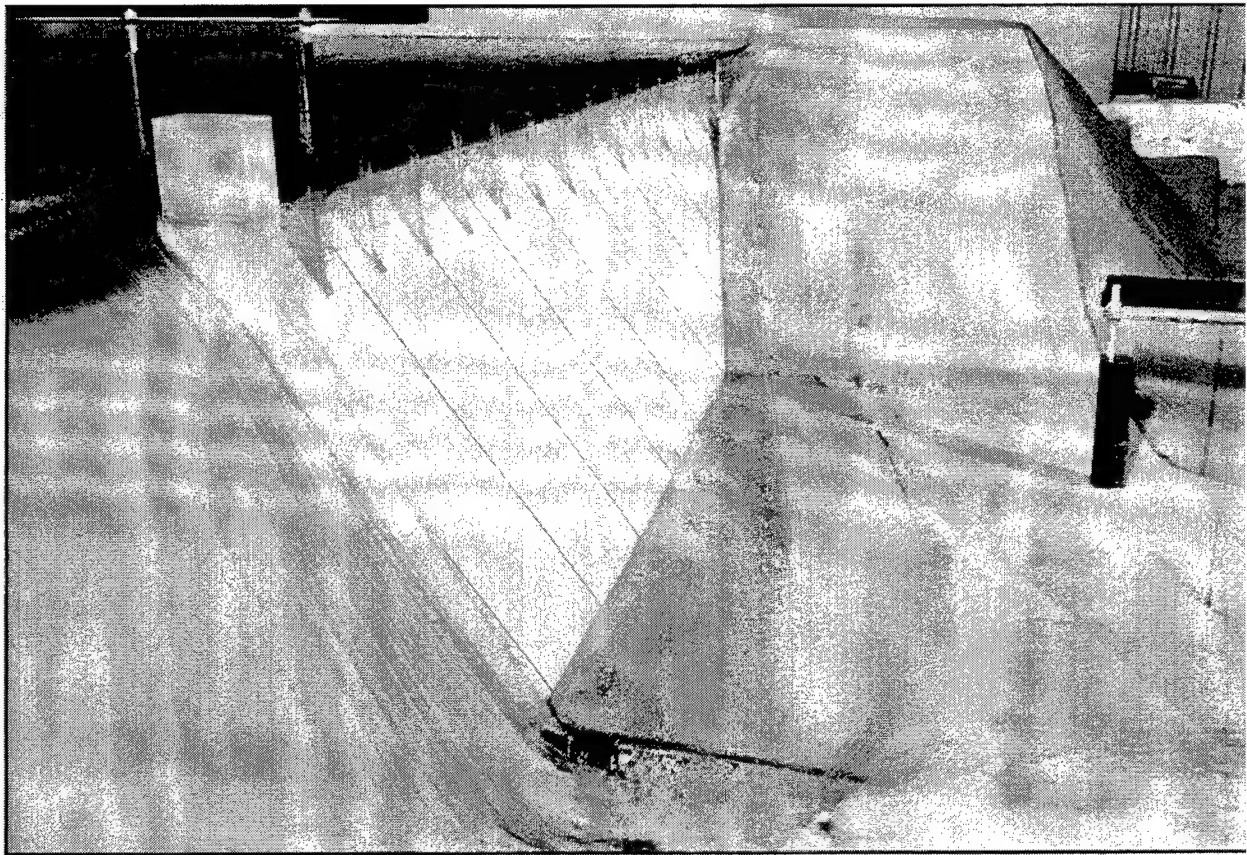
Photo 18. Type 4 design, PMF overflow on right side of dam ($Q = 373,120$ cfs; Pool = el 1196.95; TW el = 1031.5)

Photo 19. Type 4 design, PMF overflow on left side of dam($Q = 373,120$ cfs; Pool = el 1196.95; TW el = 1031.5)

Flow conditions for the PMF are shown in Photos 18-19. In Photos 18-19, dye was added to the gutter flow to observe the flow from the gutter on the apron. Maximum depths in the right gutter channel are shown in Plate 14. Velocities, shown in Plate 15, were measured to show the magnitude and location of velocities on the concrete apron during PMF flow conditions. These velocities were measured approximately 1 ft above the ground surface.

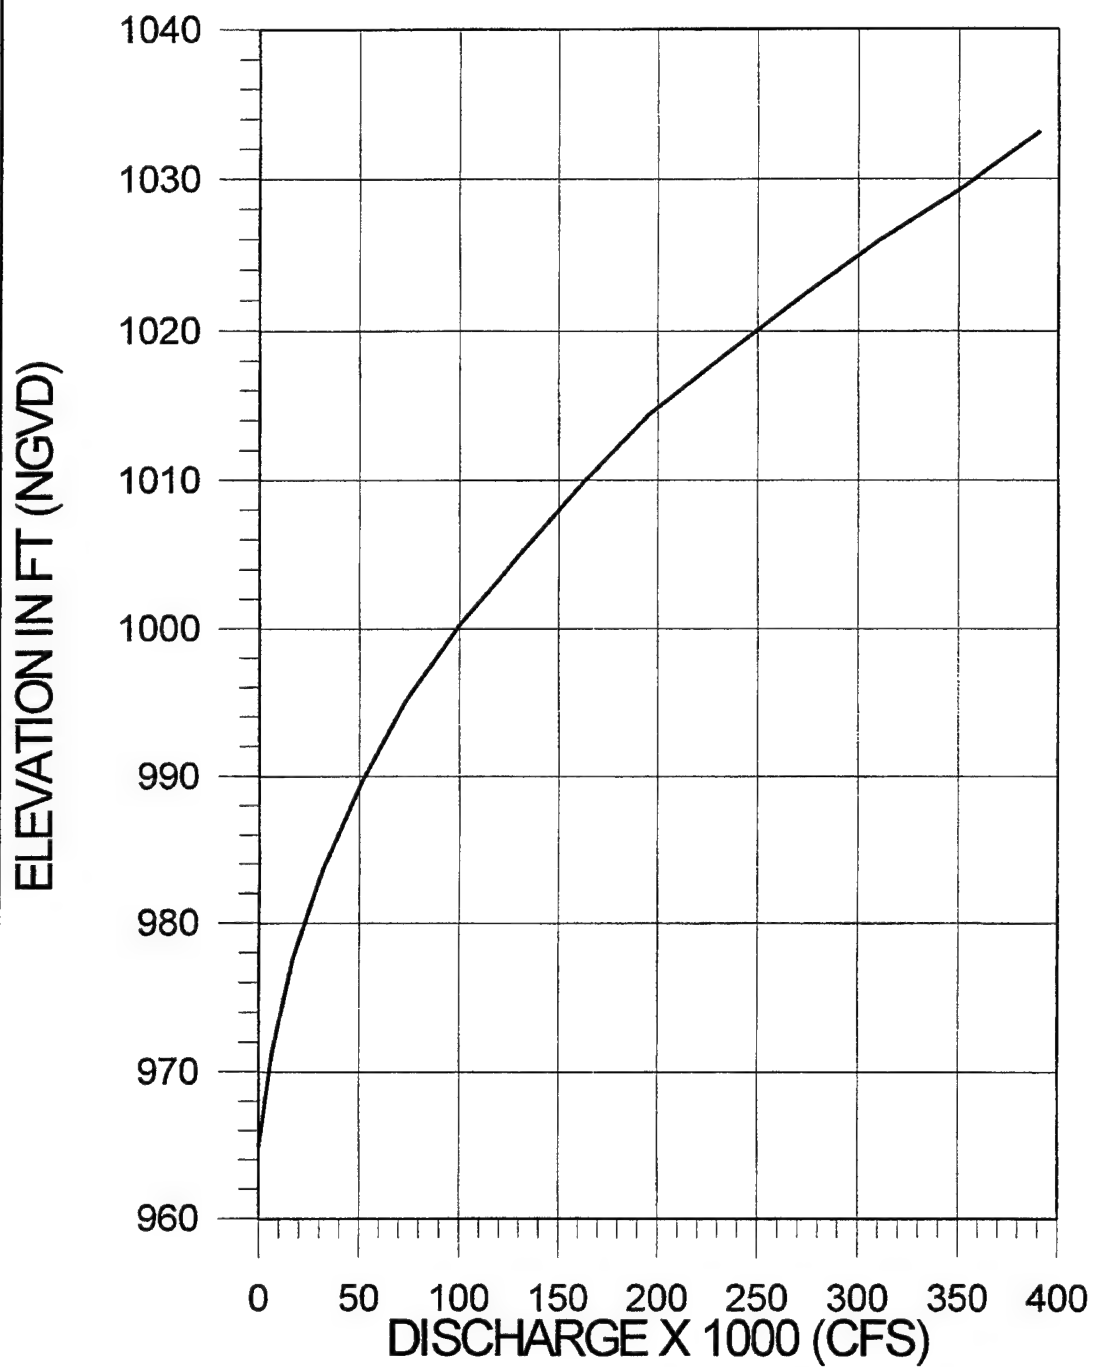
TYGART DAM
STAGE - DISCHARGE CURVE
1100 FT D/S OF STILLING WEIR

The performance of the Type 1 (existing) design was documented by observing flow over the range of discharges shown in Table 1. The tailwater elevations were set according to a rating curve furnished by the Pittsburgh District (Plate 5).

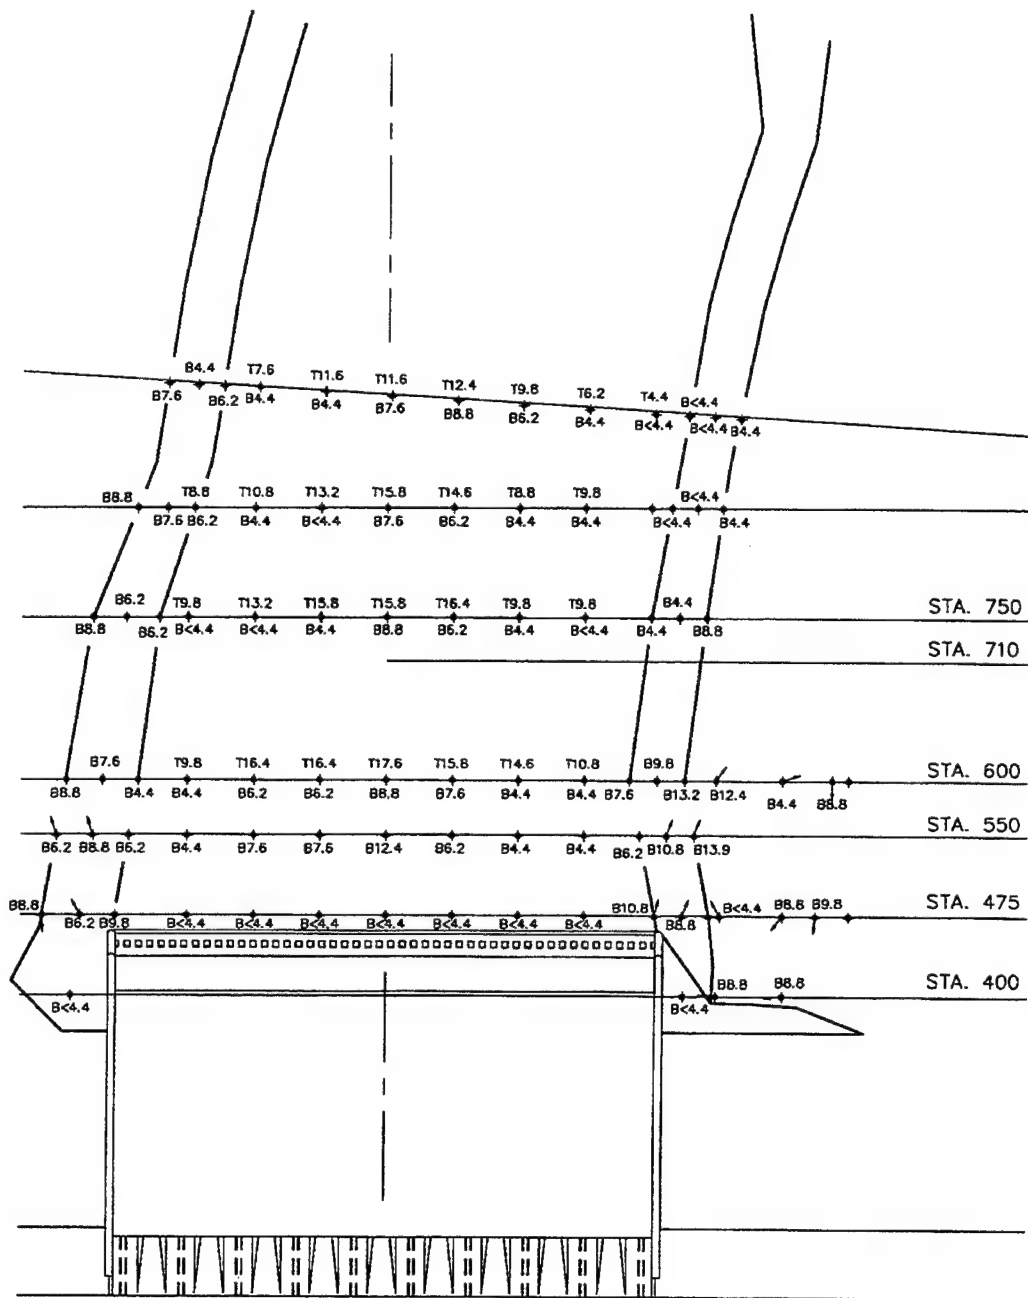
**DOWNSTREAM VELOCITIES
TYPE 1 DESIGN
CONDITION B**

VELOCITY UNITS: FT/SEC
T - 2 FT BELOW SURFACE
B - 2 FT ABOVE BOTTOM

Downstream velocities for flow conditions A, B, C, and D are shown as Plates 6-9. Average bottom velocities just downstream from the weir ranged from 4.9 ft/sec on the left side of the channel to 12.9 ft/sec just to the right of the channel center line. Surface velocities were much lower and better distributed (ranged from 2.5 to 3.1 ft/sec). Farther down the channel, the flow velocities were higher in the center of the channel, and the surface velocities were higher than the bottom velocities.

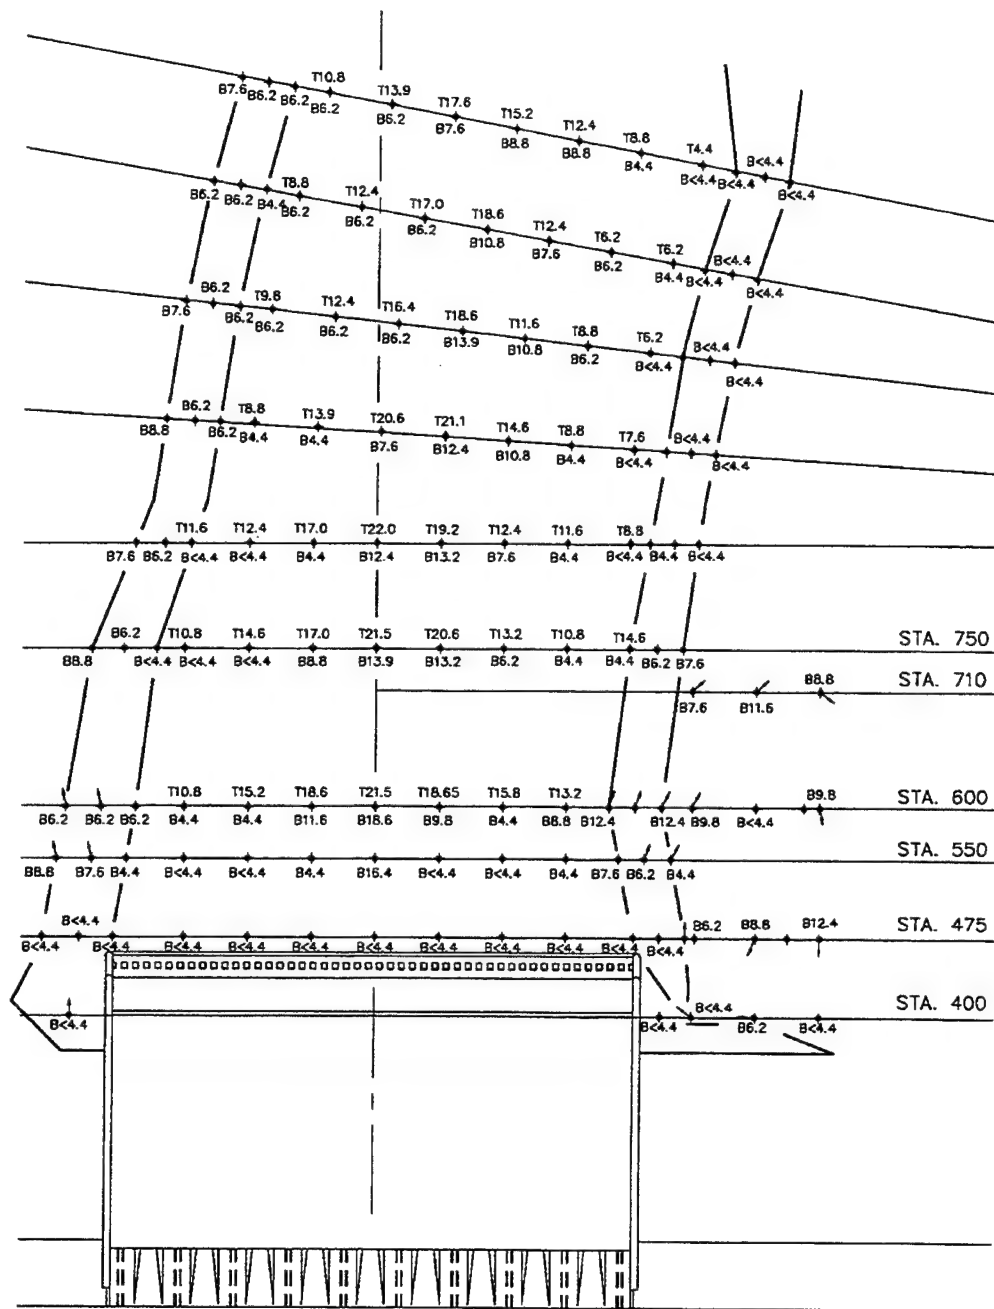
DOWNSTREAM VELOCITIES
TYPE 1 DESIGN
CONDITION D

VELOCITY UNITS: FT/SEC
T - 2 FT BELOW SURFACE
B - 2 FT ABOVE BOTTOM

changes in velocity caused by the gutter channel modifications. Comparing the downstream bottom velocities of the Type 4 (Plate 20) with those of the Type 1 (Plate 9) showed little or no change in the channel bed because of the gutter and apron modification.

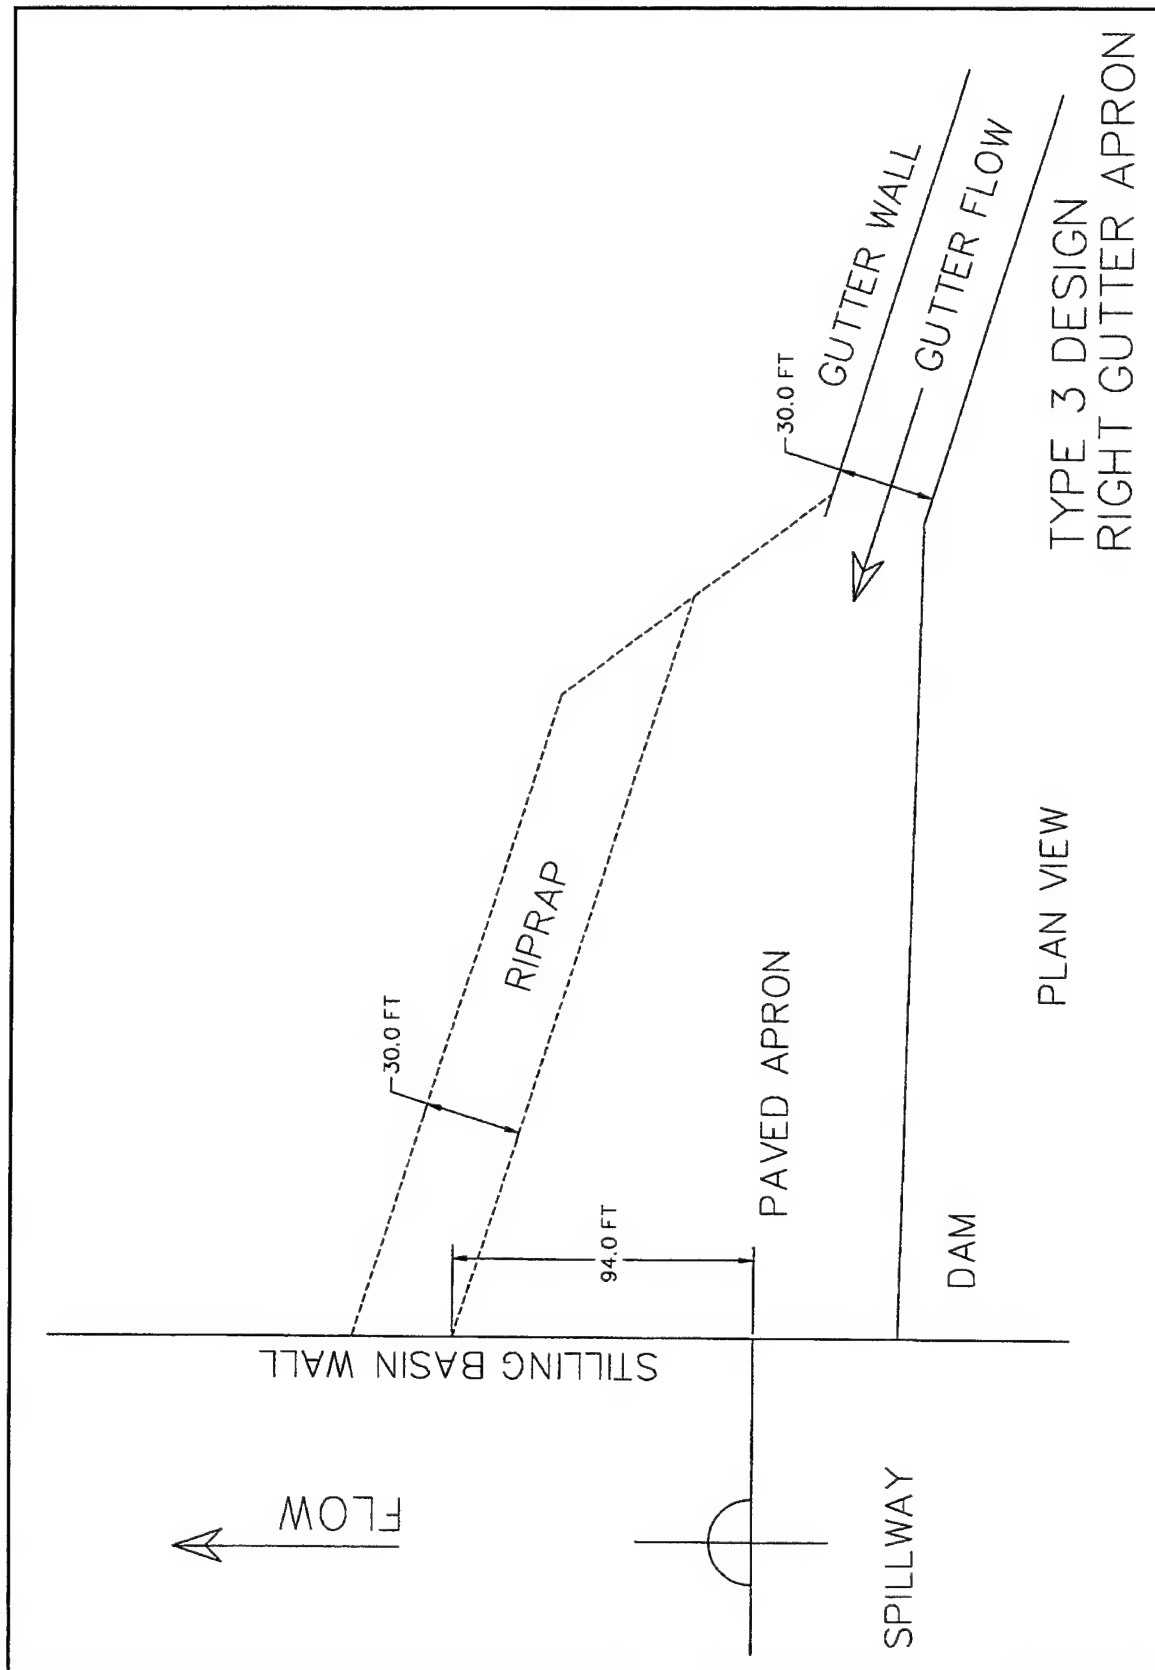
TYPE 3 DESIGN
 RIGHT GUTTER APRON

PLAN VIEW
